G-TECH HOME INSPECTION

Confidential Inspection Report

84 Twin Gables
Irvine, CA 92620

Inspection Date: April 3, 2011 09:00 AM.
Client: Tim Ou

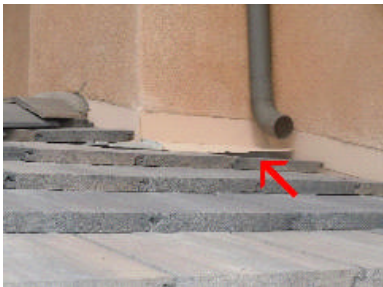
Attention Needed - Some portion of the roof flashing needs to have some repair. Further evaluation needed by licensed roofer.

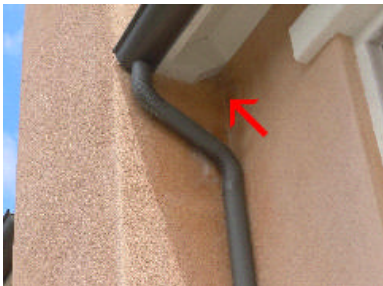
Evidence of Leakage:

Yes -

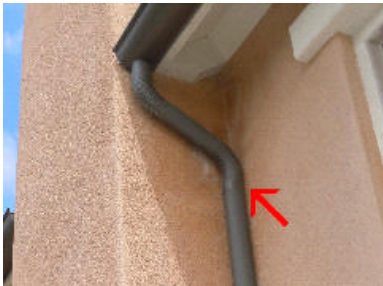
Attention Needed - The gutter system on the roof edge appears to be leaking or inadequately sloped to carry the water to the downspouts.

Need Attention, Installation of downspout extensions would help carry the water further away from the PLASTER SITE.

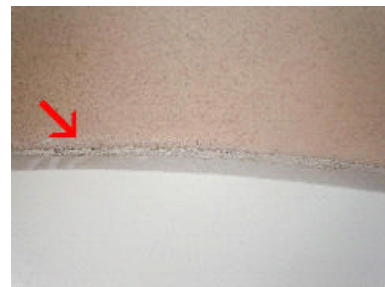
Attention Needed - The Arch in front of entry door appear to need some minor repair to prevent further deterioration.

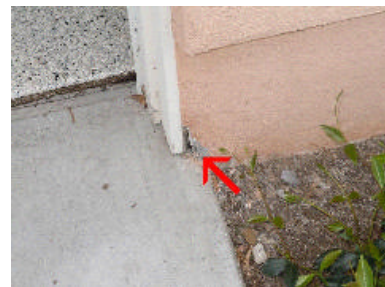
Need Attention, plaster. Minor cracks in the walls, unless noted in the room-by-room descriptions, are considered normal shrinkage or settling.

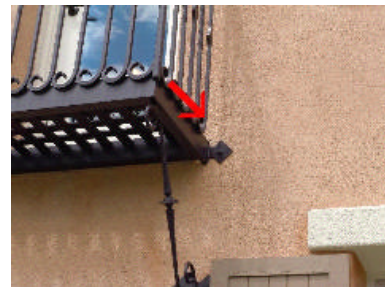
Need Attention, there is crack at the button of second floor balcony, that need touch up and paint.

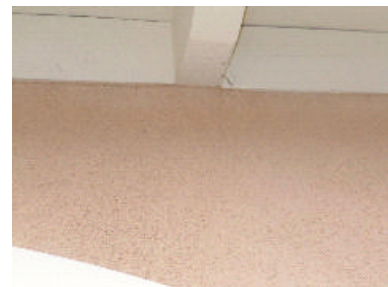
Need Attention ,plaster. Minor cracks in the walls, unless noted in the room-by-room descriptions, are considered normal shrinkage or settling.

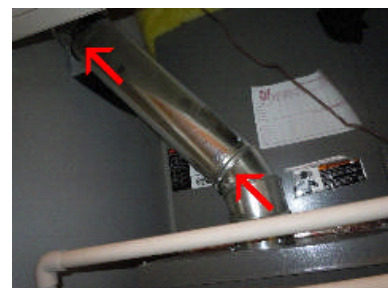
Gas-fired Appliance Flue/Vents: **Action Necessary** - Some visible portion of the flue/vent system appears to be installed improperly or is in a deteriorated condition. Action is necessary to correct this condition immediately. Need to seal around the joints.

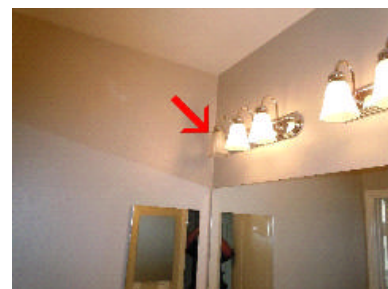
Bathroom #2: **Attention Needed** - The ceiling light fixture in this bathroom needs attention.

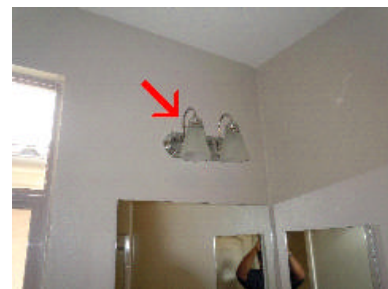
Bathroom #3: **Attention Needed** - The ceiling light fixture in this bathroom needs attention.

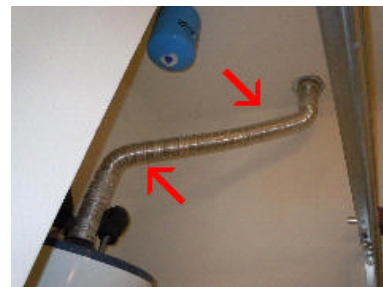
Flue/Exhaust Pipe Condition: **Need attention**, flex flue vent it is not acceptable for water heater vent, has to be solid b vent, with proper slope no more the 45 degree .

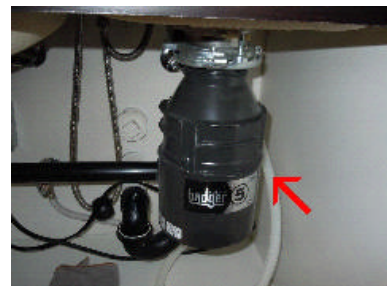
Sink and Drain Lines:	Satisfactory - The sink and drainage lines appear to be satisfactory.
Caulking Water Contact Areas:	Satisfactory - The caulking in water contact areas appears to be satisfactory.
Food Waste Disposal:	Need Attention , Brand - ; Model # - .Badger 1/2 hours power Disposal is noisy .repair needed.

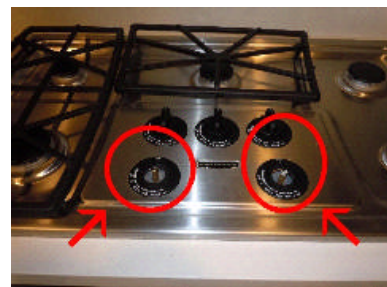
Brand - Kitchen Aid, Built-in - There is a built-in range top. They appeared to function correctly at the time of the inspection. The timers and temperature settings were not tested and are not a part of this inspection. Missing the knobs in the front.

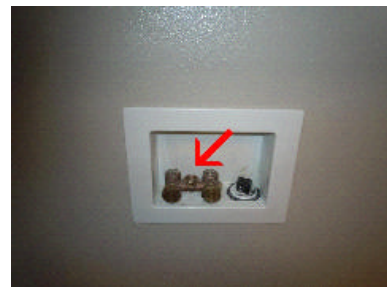
Need Attention, There is a connection box installed in the wall with both hot and cold water and a drain pipe. The drain pipe was not flood tested. There Missing the valve need repair by licensed contractor.

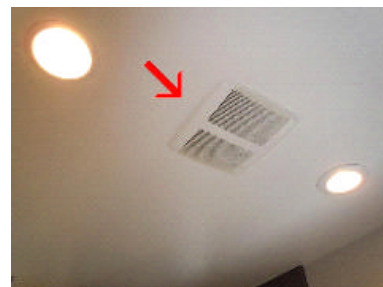
Need Attention- There is an exhaust fan installed in this bathroom, but it does not appear to be removing air at a satisfactory rate. Cleaning or repair is indicated.

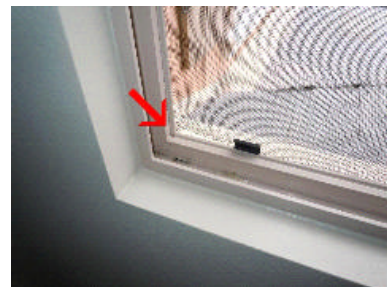
Attention Needed - The screen for this window needs repair.

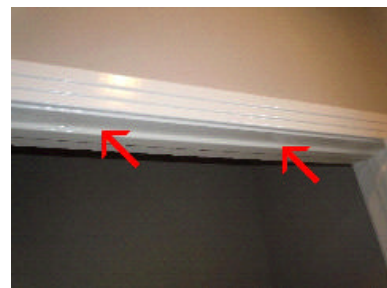
Attention Needed - The closet doors or fixtures need some adjustment or repair, need touch up and paint.

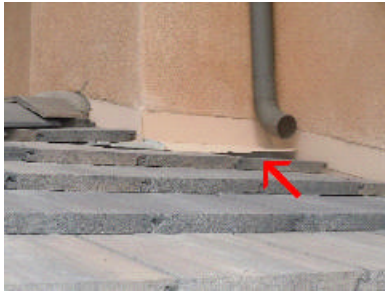
2. **Attention Needed** - Some portion of the roof flashing needs to have some repair. Further evaluation needed by licensed roofer.

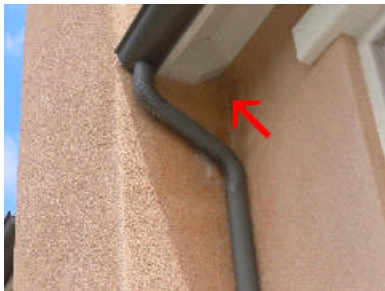
Evidence of Leakage:

3. **Yes -**

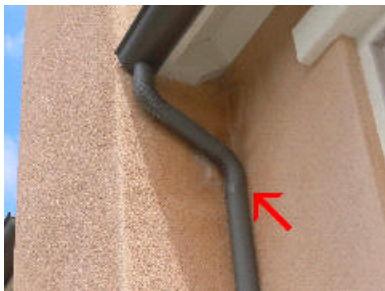
4. **Attention Needed** - The gutter system on the roof edge appears to be leaking or inadequately sloped to carry the water to the downspouts.

5. **Need Attention**, Installation of downspout extensions would help carry the water further away from the PLASTER SITE.

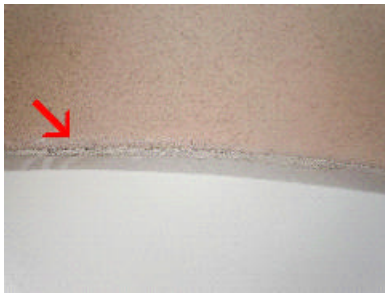
6. **Attention Needed** - The Arch in front of entry door appear to need some minor repair to prevent further deterioration.

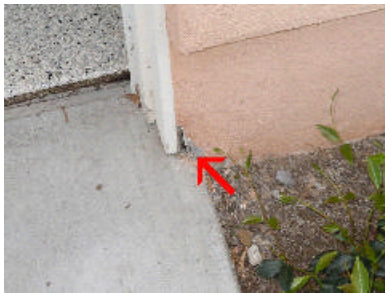
7. **Need Attention**, plaster. Minor cracks in the walls, unless noted in the room-by-room descriptions, are considered normal shrinkage or settling.

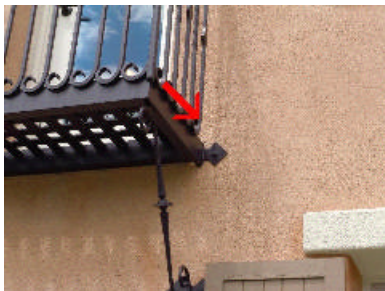
8. **Need Attention**, there is crack at the button of second floor balcony, that need touch up and paint.

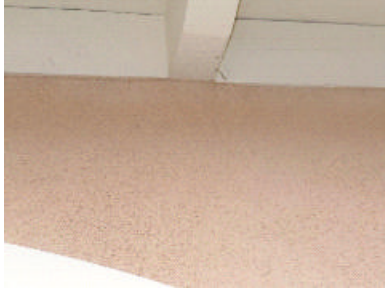
9. **Need Attention**, plaster. Minor cracks in the walls, unless noted in the room-by-room descriptions, are considered normal shrinkage or settling.

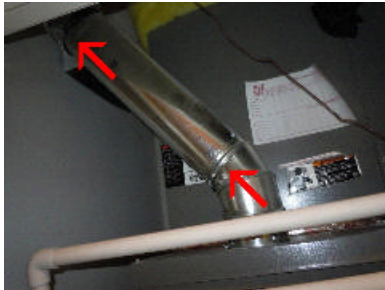
10. **Action Necessary** - Some visible portion of the flue/vent system appears to be installed improperly or is in a deteriorated condition. Action is necessary to correct this condition immediately. Need to seal around the joints.

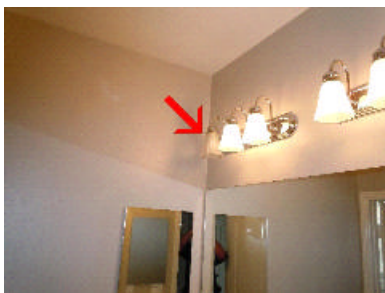
12. **Attention Needed** - The ceiling light fixture in this bathroom needs attention.

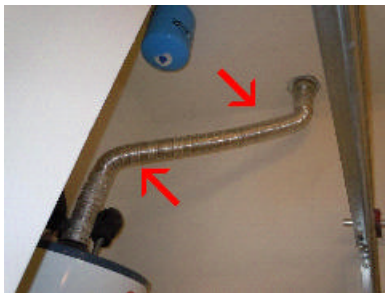
15. **Need attention**, flex flue vent it is not acceptable for water heater vent, has to be solid b vent, with proper slope no more the 45 degree .

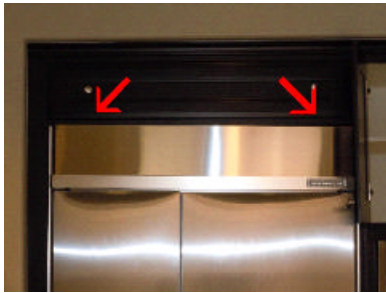
17. **Attention Needed** - There is a refrigerator installed. It appears that it does not level with floor and under the top cabinet, need adjustment.
