G-TECH HOME INSPECTION

Confidential Inspection Report

84 Twin Gables
Irvine, CA 92620

Inspection Date: April 3, 2011 09:00 AM.
Client: Tim Ou

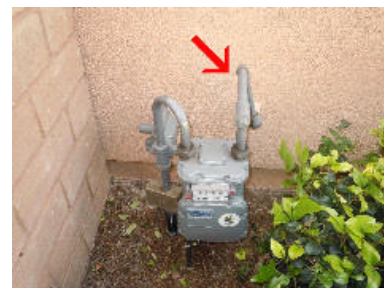
Type of Gas Supply:	Natural Gas.
Gas Appliances in Garage Area?:	Yes - Any gas appliance located on the floor in a garage must have the combustion chamber located at least 18 inches above the floor and not accessible to damage by a vehicle, or be in a separate enclosure. Appliance installation appears to be within this general guideline. Water heater.
Gas Line Primary Piping Material:	Need Attention, There is no automatic seismic Gas shut off Valve for the Gas meter in the building.

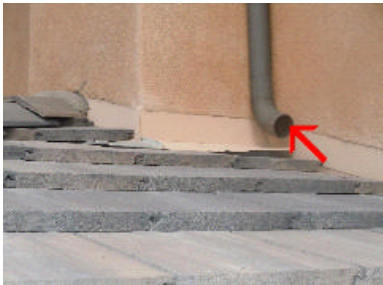
Need Attention, Installation of downspout extensions would help carry the water further away from the PLASTER SITE.

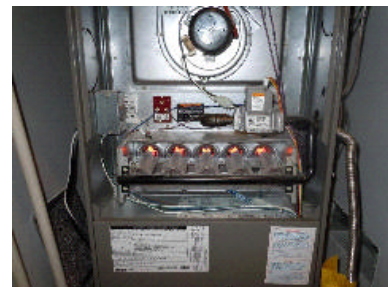
Gas-fired Appliance Flue/Vents: **Action Necessary** - Some visible portion of the flue/vent system appears to be installed improperly or is in a deteriorated condition. Action is necessary to correct this condition immediately. Need to seal around the joints.

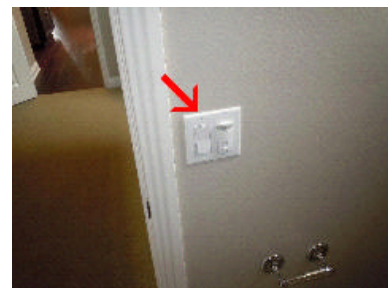
Master Bathroom:	Satisfactory - The light switch is satisfactory.
Bathroom #2:	Satisfactory - The light switch is satisfactory.
Bathroom #3:	Action Necessary - The light switch in this bathroom did not function when I attempted to turn it off or on.

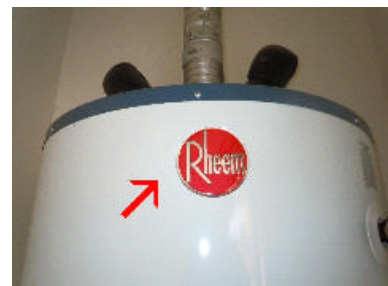
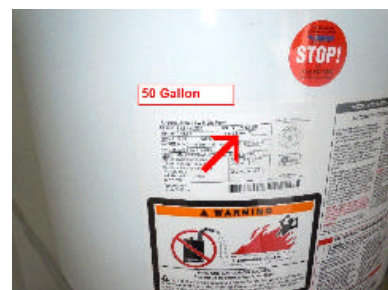
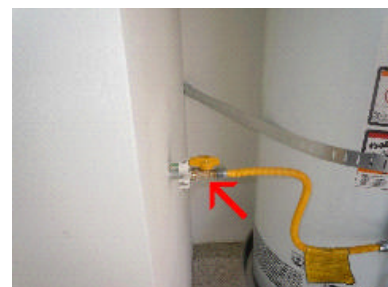
Flue/Exhaust Pipe Condition: **Need attention**, flex flue vent it is not acceptable for water heater vent, has to be solid b vent, with proper slope no more the 45 degree .

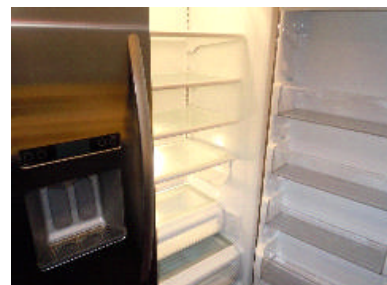
Refrigerator: Brand - ; Model # ; Serial # -Kitchen Aid Please check with the refrigerator regarding with connection of water to ice maker and water, further evaluation needed by the appliance manufacture.

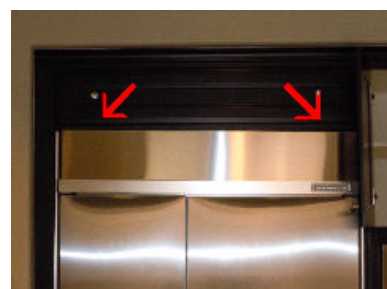
Attention Needed - There is a refrigerator installed. It appears that it does not level with floor and under the top cabinet, need adjustment.

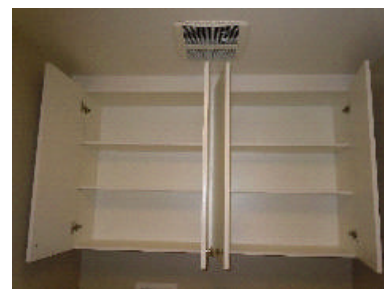
Linen Closet:

Satisfactory - The closet is functional and of average size.

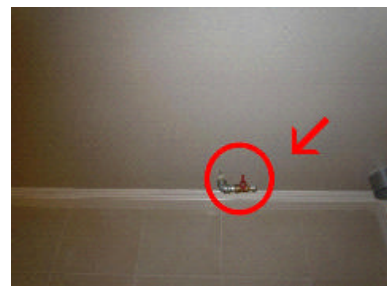
Dryer Hookup:

Yes - There is a gas line provided for a gas dryer. If you have an electric clothes dryer, you will need to have additional electrical circuitry installed.

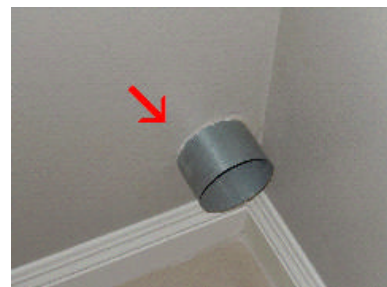
Dryer Ventilation:

Satisfactory - The dryer ventilation as installed appears adequate. The vent hood outside is clean, and the flapper is functional.

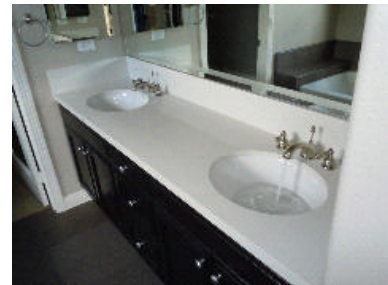
Basin and Drain Fixture:

Satisfactory - The basin and drainage fixture appears to be satisfactory.

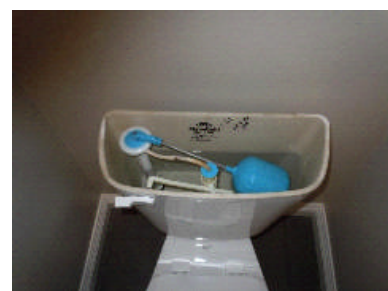
Toilet Condition

Satisfactory - The toilet in the master bathroom appears to be functional.

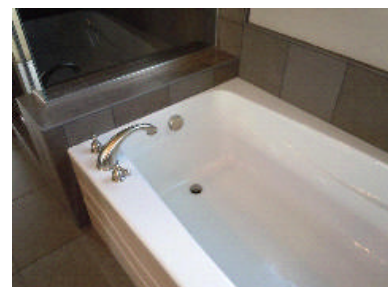
Tub:

Fiberglass Tub OK - The bathtub is a fiberglass reinforced plastic material, and it appears to be in satisfactory condition. Use caution on type of cleaning materials and method of application. The surface of the tub can be easily damaged.

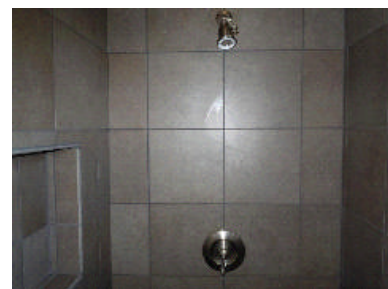
Shower/Shower Head and Mixing Valves:

Satisfactory - The shower, shower head, and mixing valves are all performing as required.

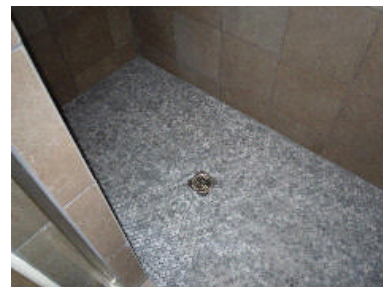
Tub/Shower Drain:

Satisfactory - The tub/shower appears to drain at an acceptable rate.

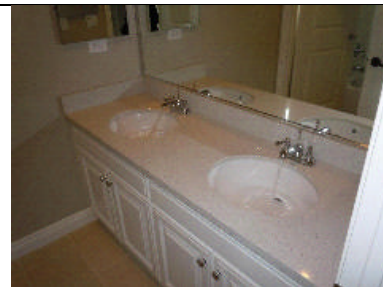
Vanity Cabinet:

Satisfactory - The vanity cabinet and top in this bathroom are satisfactory.

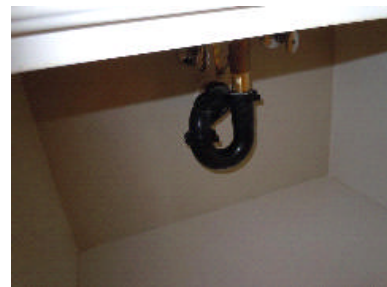
Faucet and Supply Lines:

Satisfactory - Faucets and supply lines appear satisfactory.

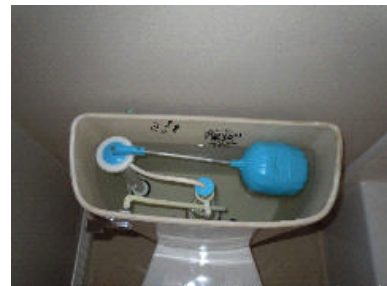
Toilet Condition

Satisfactory - The toilet in the master bathroom appears to be functional.

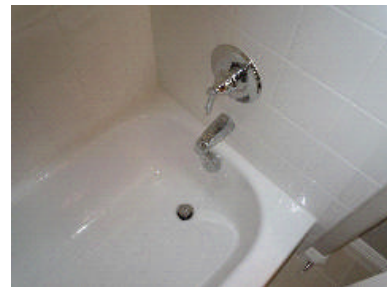
Tub:

Steel Tub OK - The bathtub is a steel material with a solid finish applied. It appears to be in satisfactory condition.

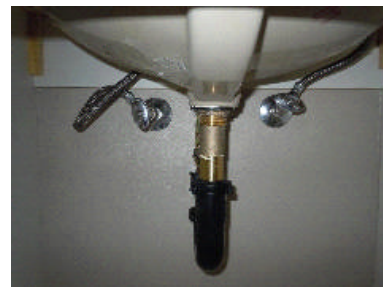
Basin and Drain Fixture:

Satisfactory - The basin and drainage fixture appears to be satisfactory.

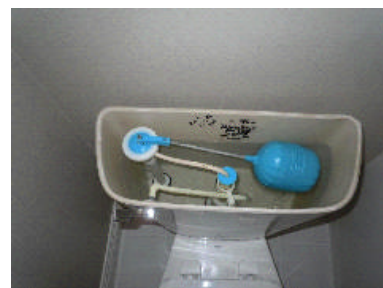
Toilet Condition

Satisfactory - The toilet in the master bathroom appears to be functional.

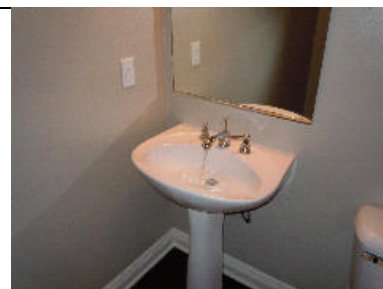
Basin and Drain Fixture:

Satisfactory - The basin and drainage fixture appears to be satisfactory.

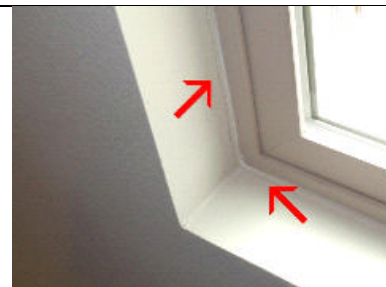
Living Room:

Walls:	Satisfactory - The walls in the room appear to be satisfactory. There is some minor cracking in the sheetrock. Most likely this is due to slight settlement or shrinkage.
Ceiling:	Satisfactory - The ceiling is functional and as I expected.
Floor:	Good - The floor covering is newer and should provide years of service. The floor covering material is hardwood.

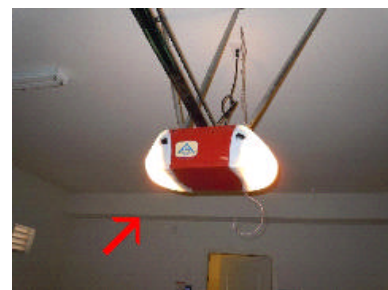
Garage Type	The garage is attached.
Size of Garage:	Two car garage.
Number of Overhead Doors	The overhead doors are made of a synthetic plastic or fiberglass.
Overhead Door and Hardware Condition:	Satisfactory - The overhead door is in satisfactory condition, and it is functional.
Automatic Overhead Door Opener:	The overhead door opener appears to function appropriately.

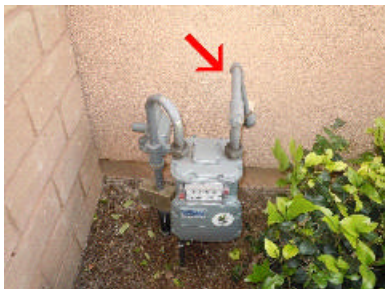
Gas Line Primary Piping Material:

1. **Need Attention**, There is no automatic seismic Gas shut off Valve for the Gas meter in the building.

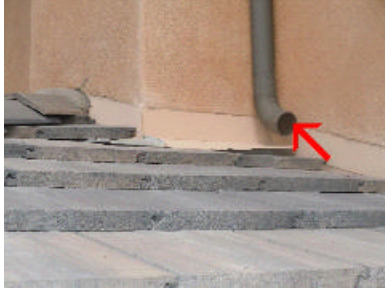
5. **Need Attention**, Installation of downspout extensions would help carry the water further away from the PLASTER SITE.

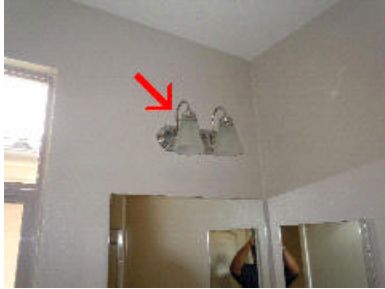
13. **Attention Needed** - The ceiling light fixture in this bathroom needs attention.

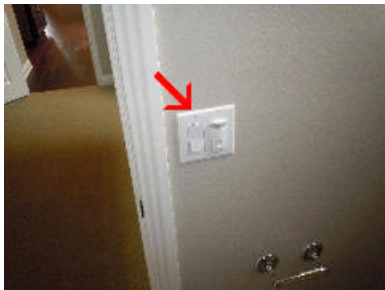
Bathroom #3:

14. **Action Necessary** - The light switch in this bathroom did not function when I attempted to turn it off or on.

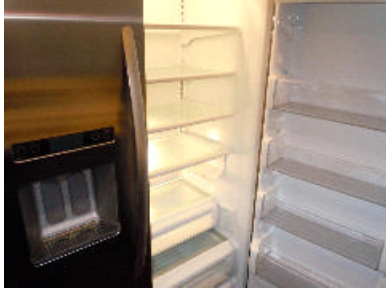
17. **Attention Needed** - There is a refrigerator installed. It appears that it does not level with floor and under the top cabinet, need adjustment.

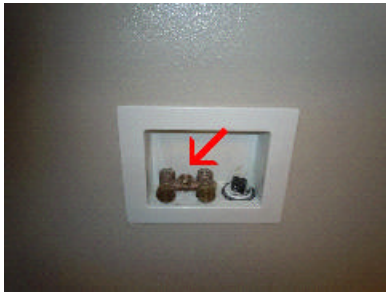
Washer Hookup:

Need Attention, There is a connection box installed in the wall with both hot and cold water and a drain pipe. The drain pipe was not flood tested. There Missing the valve need repair by licensed contractor.

18. **Need Attention**, There is a connection box installed in the wall with both hot and cold water and a drain pipe. The drain pipe was not flood tested. There Missing the valve need repair by licensed contractor.

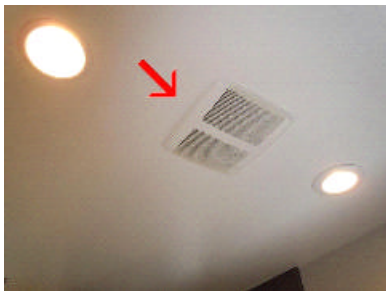
Ventilation Fans:

Need Attention- There is an exhaust fan installed in this bathroom, but it does not appear to be removing air at a satisfactory rate. Cleaning or repair is indicated.

19. **Need Attention**- There is an exhaust fan installed in this bathroom, but it does not appear to be removing air at a satisfactory rate. Cleaning or repair is indicated.

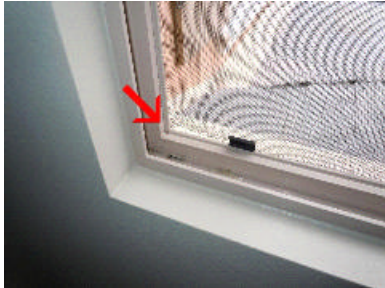
Windows:

Attention Needed - The screen for this window needs repair.

20. **Attention Needed** - The screen for this window needs repair.

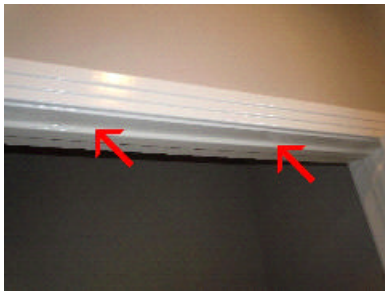
Closet:

Attention Needed - The closet doors or fixtures need some adjustment or repair, need touch up and paint.

21. **Attention Needed** - The closet doors or fixtures need some adjustment or repair, need touch up and paint.

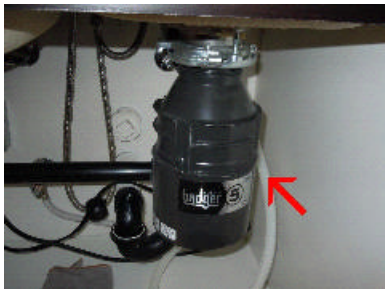
Sink and Drain Lines:	Satisfactory - The sink and drainage lines appear to be satisfactory.
Caulking Water Contact Areas:	Satisfactory - The caulking in water contact areas appears to be satisfactory.
Food Waste Disposal:	Need Attention , Brand - ; Model # - .Badger 1/2 hours power Disposal is noisy .repair needed.

2. **Need Attention**, Brand - ; Model # - .Badger 1/2 hours power Disposal is noisy .repair needed.
